## Devil's Slide/Hwy 1 Storm Repair

Daily Updates from Bijan Sartipi

**Daily Update**  
June 16

Devil's Slide (post mile 39.14)

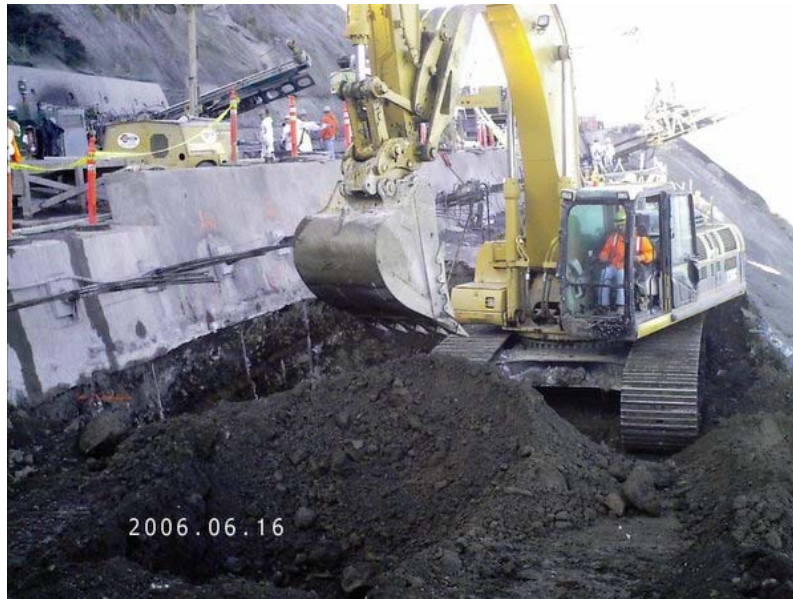
Excavating for wall B

- Whaler (bracing) wall construction:  
Whaler wall 'A' (upper level ocean side) – complete.  
Whaler wall 'B' (lower level ocean side) – excavation continued today.

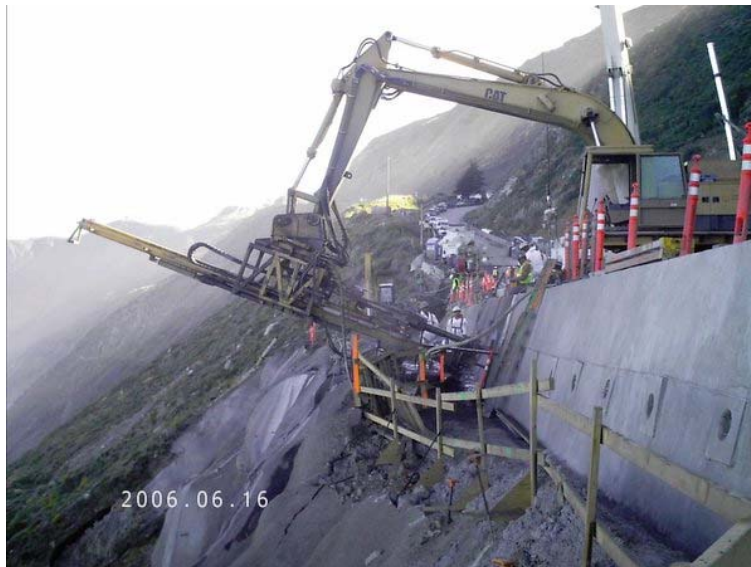
Drilling at wall A using the reach over rig.

- Drilling and tie back installation:  
Whaler wall 'A' – drilling continued using the reach over rig.  
Stressing tie back cables also took place.

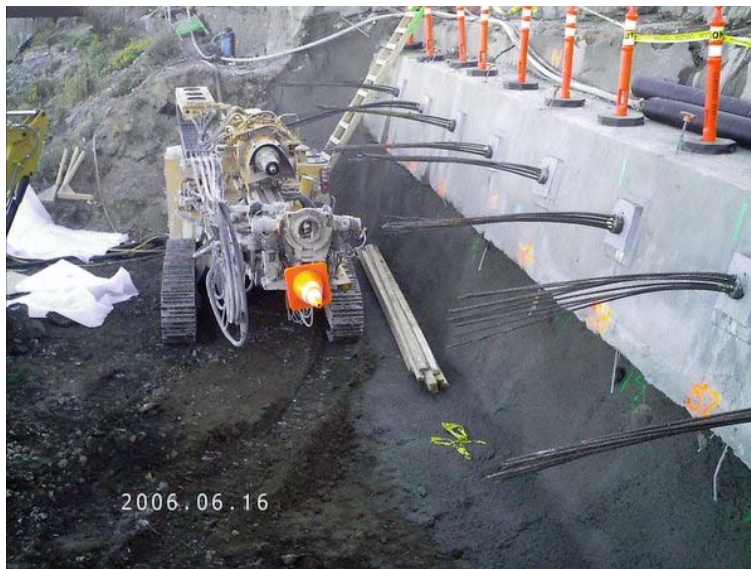
Stressed cables – wall B

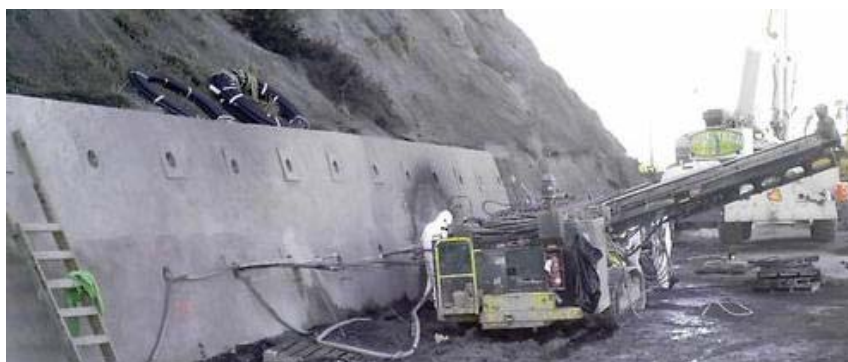
Drilling at wall C

Whaler wall 'C' – drilling continued to-day.
